Engineering/Remediation
Resources Group, Inc.
185 Mason Circle, Suite A
Concord, CA 94520

February 15, 2005

Review of Silacci, Beebe Family Ranch, Wilson Beebe, and Valley Ford (Briggs) Tire Sites
Petaluma, CA

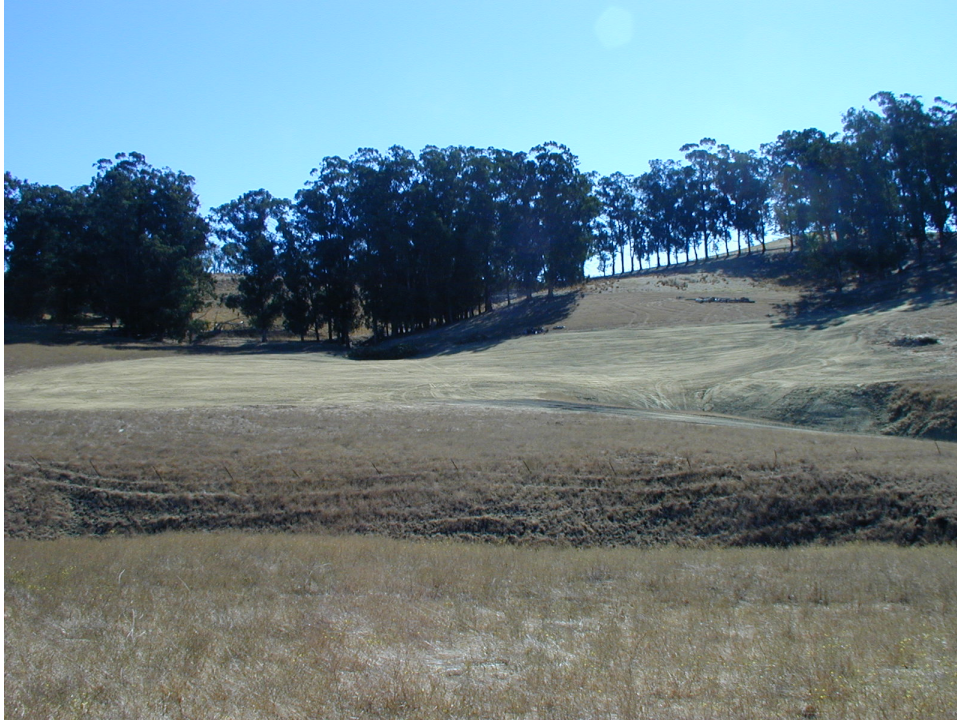
The attached photographs, S1 and S2 show Site A shortly after the restoration work was completed. S3 shows Site B after restoration work was completed. These photos were taken prior to my visit.

S1- Silacci Site A restoration grading completed.

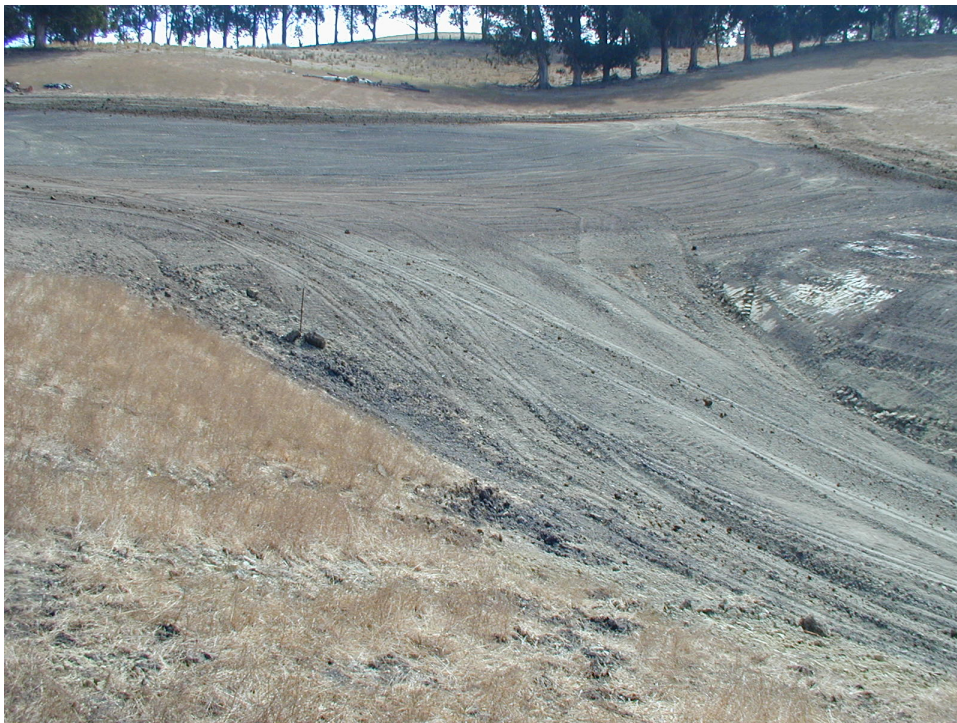
The As-Built Plan does show a couple changes that are different from the approved Grading and Drainage Plans. The Grading Plan accurately depicted the extent of the tire piles at both sites. However, on the As-Built Plan, the limits of the tire pile at Site A has been inaccurately extended downstream of the actual tire pile. The Grading Plan called for riprap at the outlets of the two sites; this rip-rap was not installed, and is not shown on the As-Built plan. The final grading contours of Site A shown on the As-Built Plan do not match the Grading Plan contours for this area. The grades are up to 8 feet lower over the central area of Site A. At Site B, the final grading contours directly over the tire removal area are within 1 to 2 feet of the design. Downstream of the tire removal area a wedge of fill up to 8 feet deep was placed in the existing channel. ERRG has no documentation or revised plans showing if these changes to the design had been approved or if the full plan was not fully implemented.

S2 - Silacci Site A complete and hydroseeded. Area shown is slope dropping into outlet channel. Rip rap proposed at bottom of slope not installed.

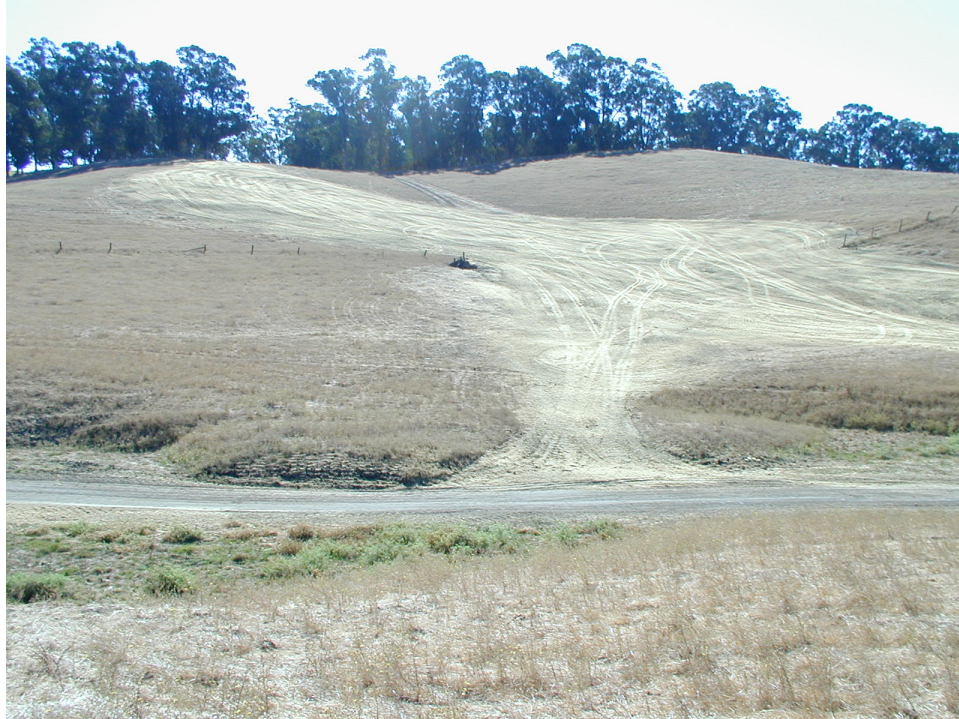
S3 - Silacci Site B restoration grading completed and hydroseeded.

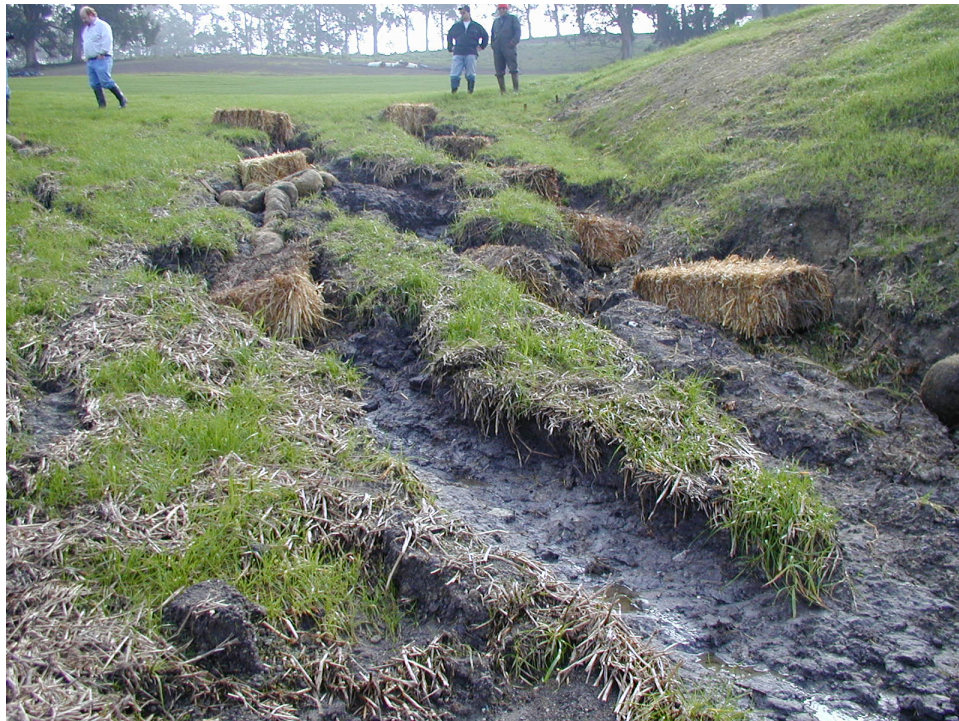
completion of the removal work in the area, and then buried during the backfill and restoration efforts. The areas directly above these remaining tires showed no evidence of erosion and held up well. However, erosion at the site took place downgradient of the tire areas, in the areas where the surface flow was concentrated as it was directed into the existing drainage channels leading to the main drainage channel through the site. These are the areas where you would most likely expect erosion do to the higher flow velocities in the smaller cross-sectional areas, and these are the areas where the Grading and Drainage Plans had proposed the placement of rip rap as part of the erosion control features.

At the eastern area, Site A, the significant erosion took place along the western side of the channel extending approximately 50 feet. Several channels were cut into the ground surface covering a triangular area approximately 10 feet wide at the top narrowing down to approximately 2 feet wide as the separate channels came together. The depths ranged from 6 inches to about 2 feet at the deepest point. This erosion took place at the proposed rip rap location. The installation of the proposed rip rap might have significantly reduced the erosion damage at this location. Attached photos, S4 and S5, show the erosion at Site A.

S4 - Silacci Site A after December 30-31, 2005 storm event. Erosion at downstream edge of tire pile area on slope dropping into outlet channel.

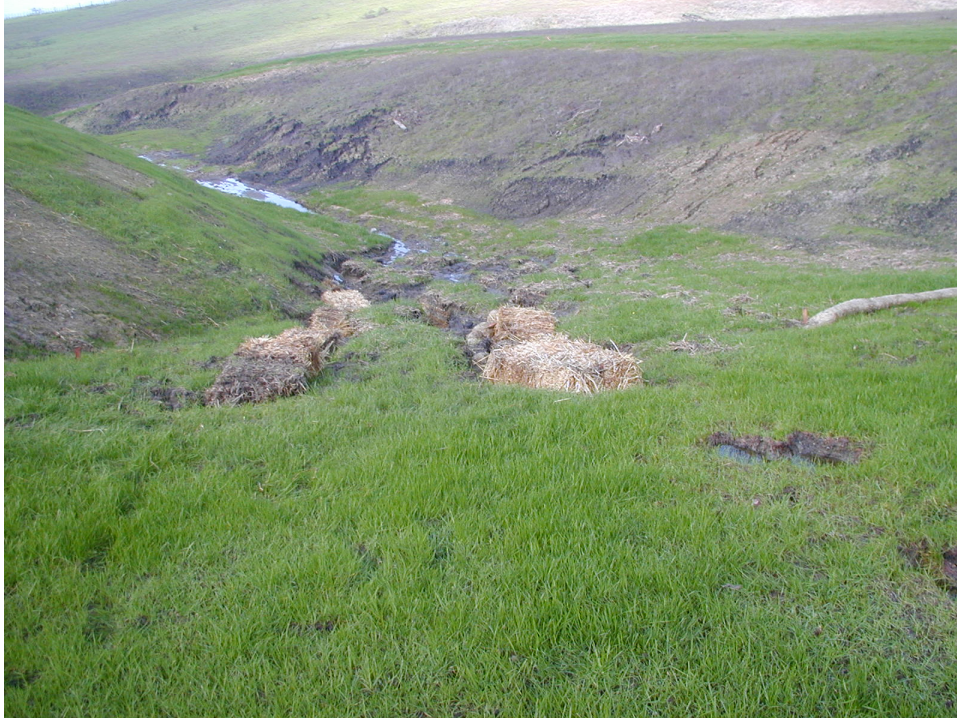
S5 - Silacci Site A after December 30-31, 2005 storm event looking downstream to outlet channel. Rip rap was proposed at the bottom of slope where channel narrows.

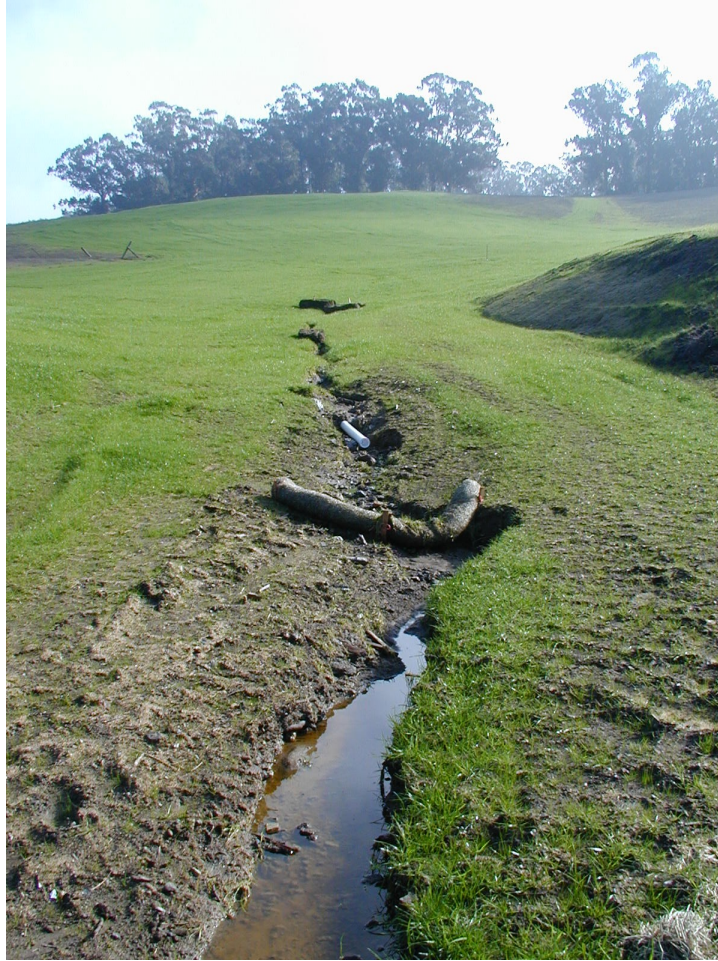
At the western area, Site B, the erosion was a single channel approximately 100 feet long, 6 to 12 inches deep, and approximately a foot wide. This channel started well below the footprint of the original tire locations, and appears to have cut into the wedge of fill placed in this area. In this case, the erosion took place downstream of the proposed rip rap location. The installation of the rip rap may not have significantly changed the erosion in this area. Attached photo, S6, shows erosion at Site B.

S6 - Silacci Site B erosion from December 30-31, 2005 storm event. Erosion downstream of tire removal area.

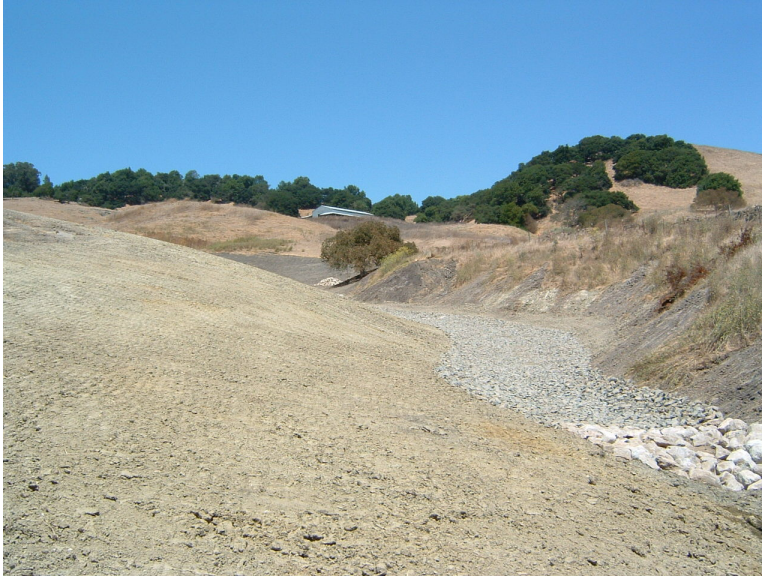
The attached photographs, B1 and B2, show the North Pile area with rock blanket layer and Middle Pile area grading after the bulk of the restoration work was complete. These photos were also taken prior to my visit.

B1 - Beebe Ranch north tire pile area completed with rock.

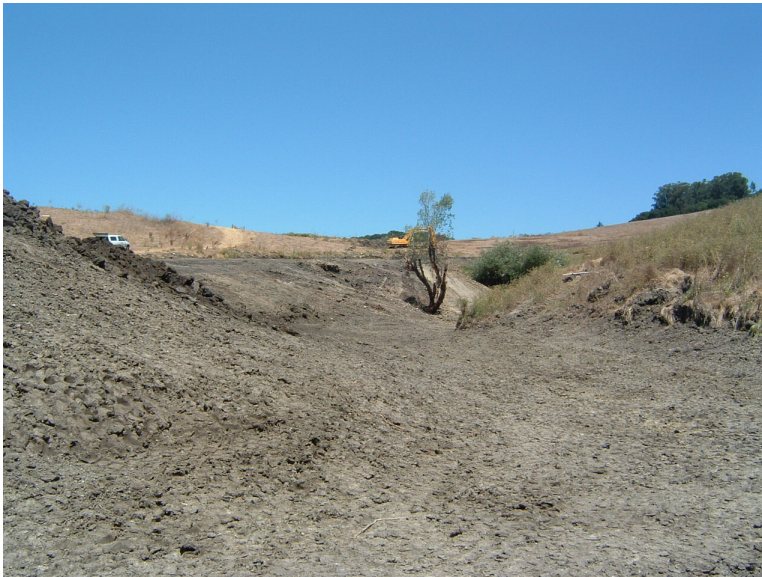
B2 - Beebe Ranch middle tire pile area at final grade.

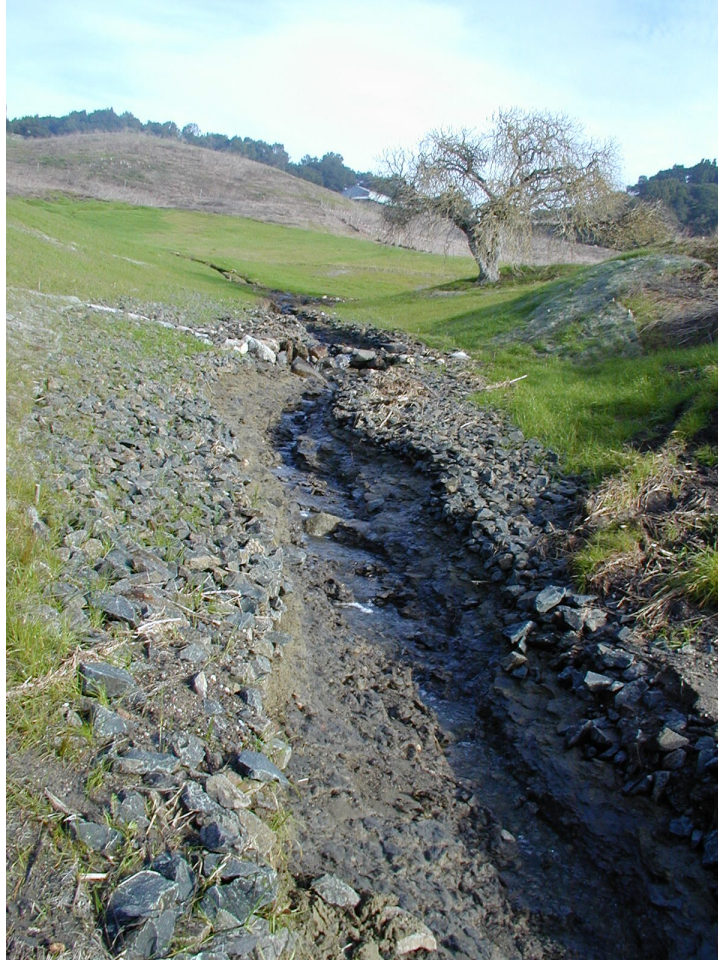
Beebe Family Ranch: At the Beebe Family Ranch, there was erosion mainly confined along the main channel through all three areas. In the North Tire area, a deep flow path had been cut through the surface rock blanket layer in the floor of the restored channel and into the soil layers below. The Middle and South areas had shallower flow paths cut into the surface of the channel. The rock check dams held up and are still in place. There was some soil slippage from the east bank in a few locations, but very localized. The east bank was not disturbed during the tire removal and did not receive any regrading during the restoration process. The west bank which had extensive regrading and restoration work done, held up well.

The attached photo, B3, shows the channel cut through the rock blanket layer in the North Pile area. Photo B4, shows the shallow channel cut through the Middle Tire area.

The appearance of smaller channels on the flat bottom of the restored stream similar to those in the Middle and South areas is not unexpected and would have most likely developed in time. The storm event speeded up the process. In the North Area, greater flow velocities were anticipated as indicated by the design and installation of the rock blanket layer. The depth of the cuts through that layer were more than you would expect based upon the erosion controls in place.

B3 - Beebe Ranch North tire area after December 30-31, 2005, storm event. Erosion 1-2 feet deep noted in channel bottom.

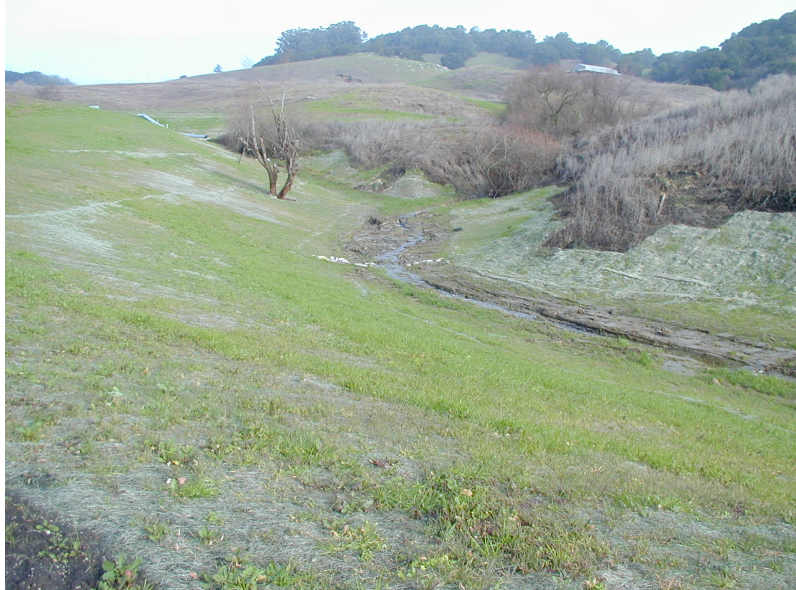
B4 - Beebe Ranch Middle tire area after December 30-31, 2005 storm event. Erosion ~ 1-foot deep in channel bottom.

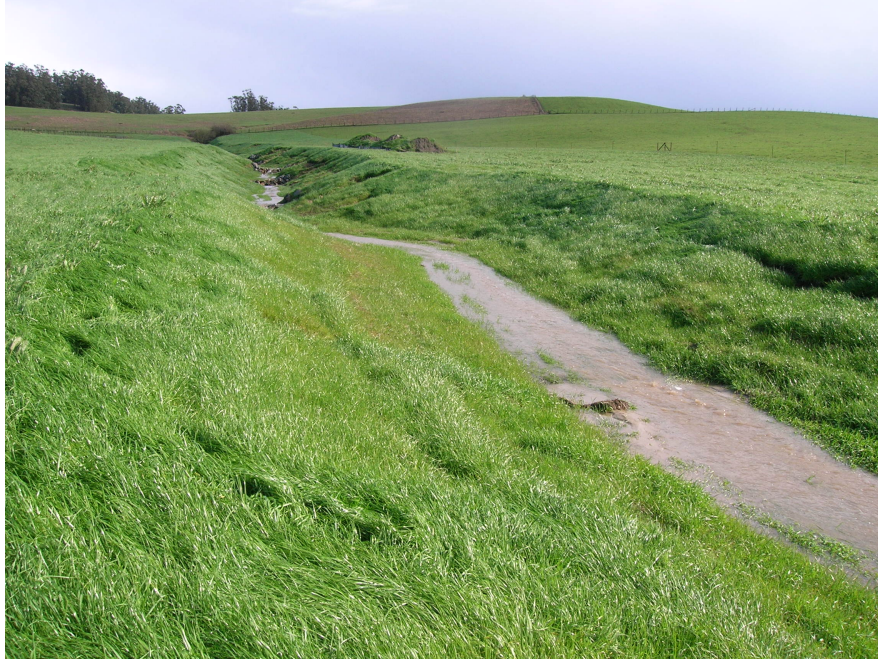
Valley Ford Briggs: At the Briggs site, the major erosion took place away from the main restoration area. The main channel was not impacted by the storm events. This channel had been regraded and rock check dams installed at intervals along the length. The only erosion damage along the main channel was at one section of the side slope of the main channel where surface flow from the adjacent pasture had cut down into the bank on the north side.

Photo VF1 shows the main channel after the storm event, Photo VF2 shows the east tributary erosion.

VF1 - Valley Ford (Briggs) main drainage channel. Property owner indicated water flowed 10' deep in channel during December 30-31 storm event

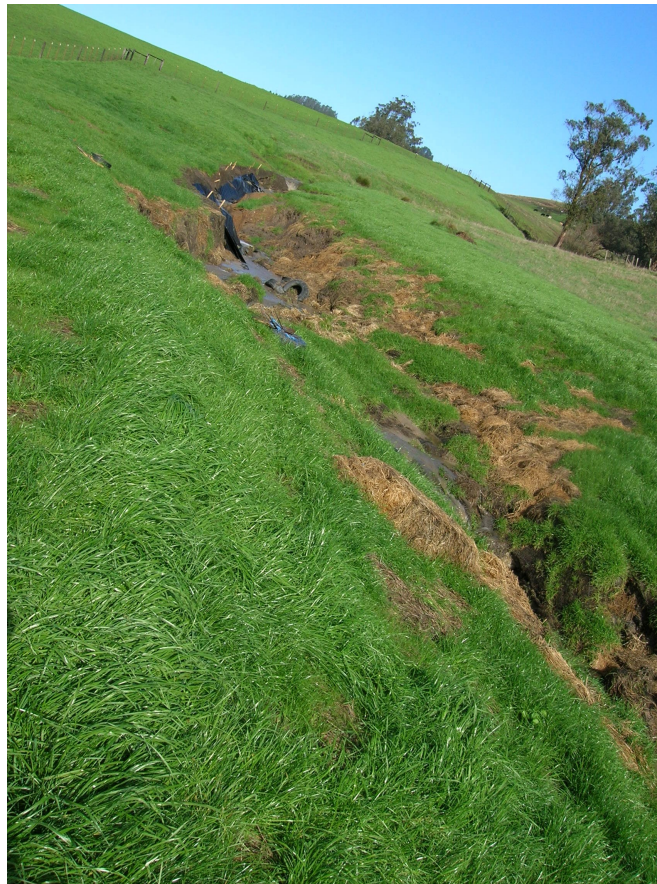
The majority of the erosion damage at the Briggs site was in the east tributary that enters the main channel at the east end of the restoration area. This ditch had only jute matting placed on the slopes and bottom and temporary hay bales placed at intervals along the ditch. During the storm, several areas had soil eroded out from underneath the matting, and hay bales pushed down stream, the bottom of the ditch had been cut down a foot or more in spots.

VF2 - Valley Ford (Briggs) east tributary drainage erosion after the December 30-31, 2005 storm event

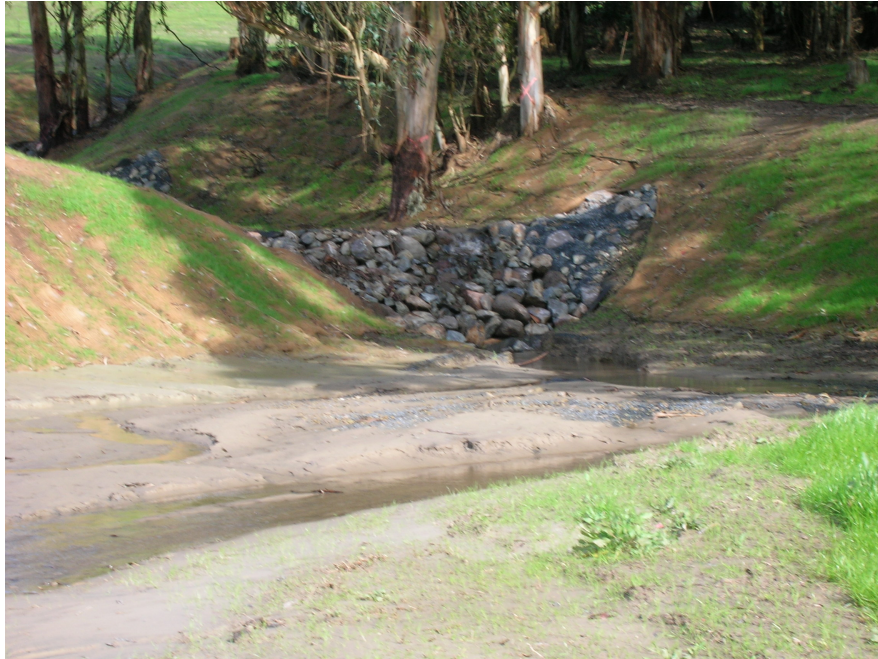
Wilson Beebe: At the Wilson Beebe site, the restoration to the tire removal area on the east side of the property held up well. The rock in the channel and the two basin areas showed little effect from the storm. There was a small slide on the upper end of the upper basin that will need to be repaired. Photos, WB1 and WB2, show the west side drainage elements. Photo WB3 shows the upper basin on the east side.

WB1 - Wilson Beebe West side after December 30-31, 2005, storm event.

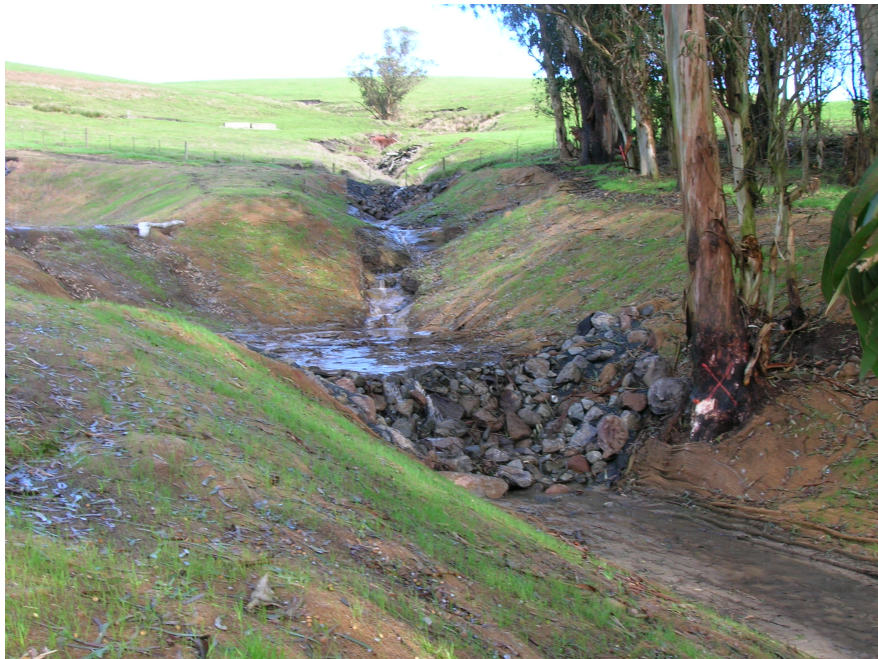
WB2 - Wilson Beebe West side after December 30-31, 2005, storm event.

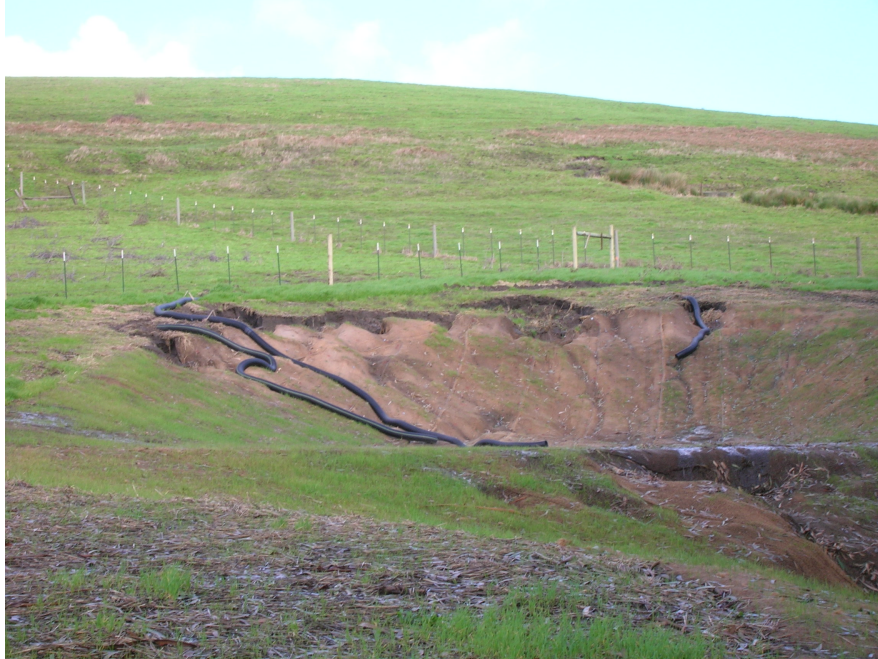
WB3 - Wilson Beebe West side after December 30-31, 2005, storm event. Erosion above cut slope.

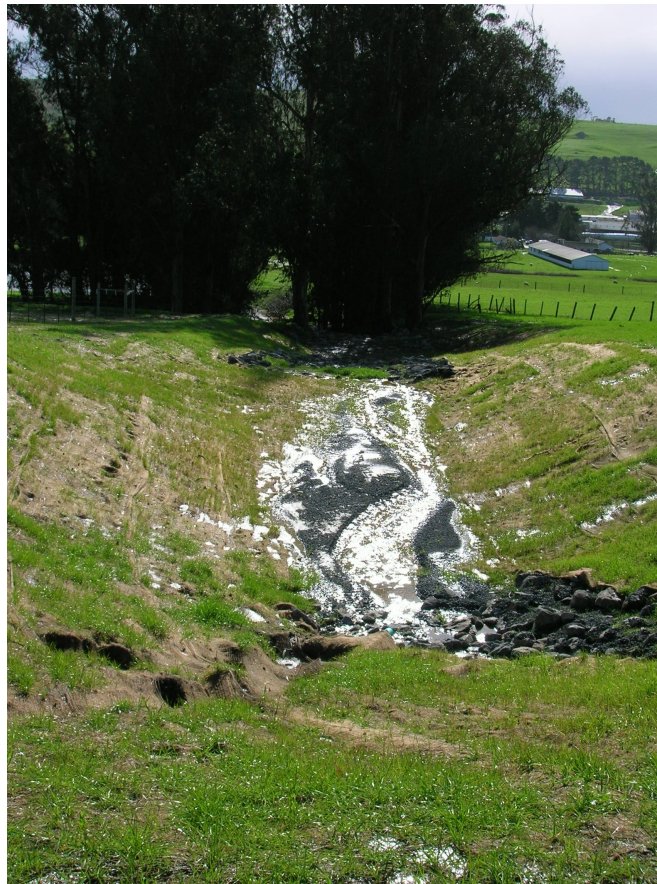
The restoration work on the west side of the property had more impacts from the storm events. Again, the main channel and basin held up well. There was one location adjacent to the main channel that was damaged by the storm. The soil around a subdrain pipe feeding into the channel has been washed out, leaving a 2 foot wide cut that was up to 3 feet deep as it cut back into the bank. The jute matting covering the bank is suspended over this cut.

The attached photo WB4 shows the main west channel and WB5 shows the area adjacent to the west channel, above the west basin.

WB4 - Wilson Beebe east side rock lined drainage after December 30-31, 2005 storm.

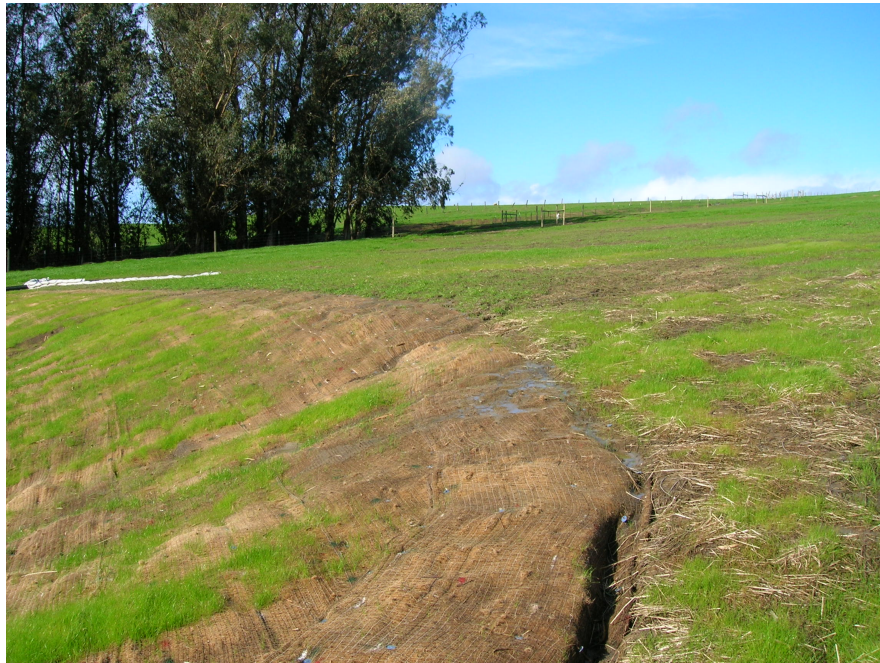
East of the main channel, two gullies where tires had been removed had been backfilled up to the surrounding grade. The surface soils showed signs of erosion with channels cut across the surface up to 6 inches deep. These areas could continue to erode if not addressed.

WB5 - Wilson Beebe east side area showing change in slope and placement of erosion control blanket for slope protection. Picture taken after after December 30-31, 2005 storm.
